# ERRATA SHEET

## RV-8803-C7

### Silicon Limitation

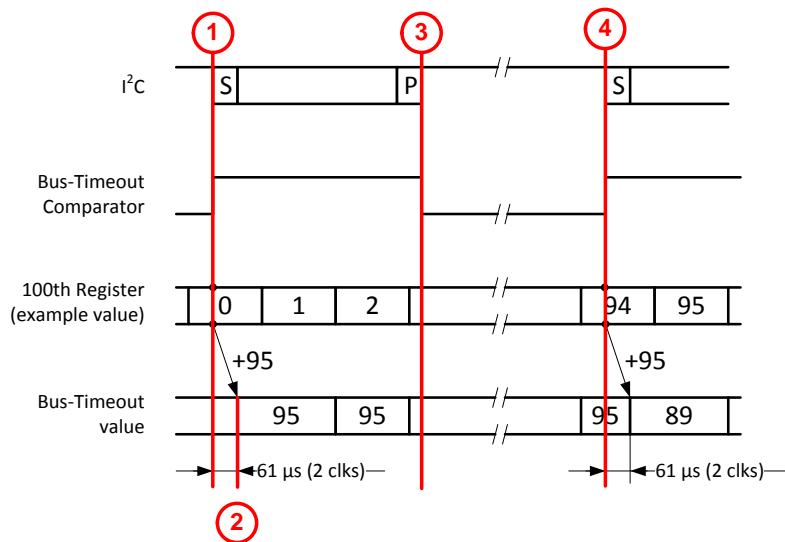
#### Initialization of the I<sup>2</sup>C Interface Bus-Timeout by RV-8803-C7:

1. At START condition, the Bus-Timeout Comparator is enabled.
2. It takes 2 clocks 32'768 Hz (61 μs) to read the value of the 1/100th seconds, adding 95/100th and write this as a Bus-Timeout target into the comparator.
3. At STOP condition, the comparator is disabled.
4. At the consecutive START (after STOP), the comparator is enabled with previous Bus-Timeout target value before the next value is calculated and written into the comparator.

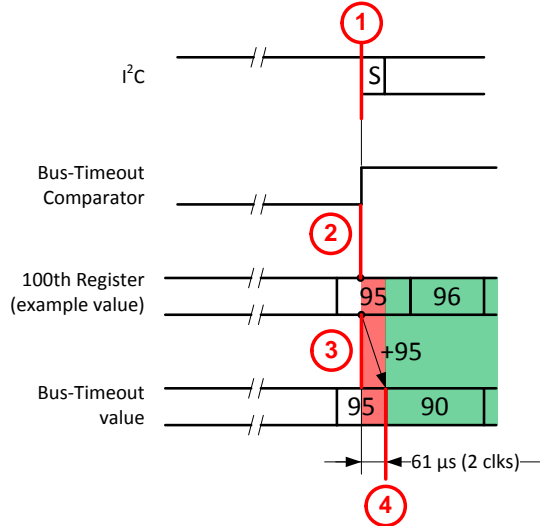
**Erroneous Bus-Timeout Reset Scenario 1: New START exactly 950 ms after previous START.**

- 1. At START condition, the comparator is enabled.
- 2. At the consecutive START the comparator is enabled with previous Bus-Timeout target value.
- 3. If the actual 1/100th of Second matches with the previous Bus-Timeout target value, a RESET of the I<sup>2</sup>C Interface will be triggered immediately.
- 4. It takes 2 clocks 32'768 Hz (61 μs) to update the new Bus-Timeout target value.

Summarized: At START condition of the I<sup>2</sup>C Interface the Bus-Timeout comparator is enabled. If there is a match between the current value in the 1/100th Seconds register and the previous Bus-Timeout value, the comparator triggers an I<sup>2</sup>C Bus-Timeout RESET and the RV-8803-C7 will reply immediately with “no acknowledge”.

It's recommended to follow I<sup>2</sup>C standard protocol and check ACK "acknowledge". When "no acknowledge" is detected, repeat communication procedure beginning with I<sup>2</sup>C Start.

Workaround: Repeat I<sup>2</sup>C communication procedure maximum 4 x times.

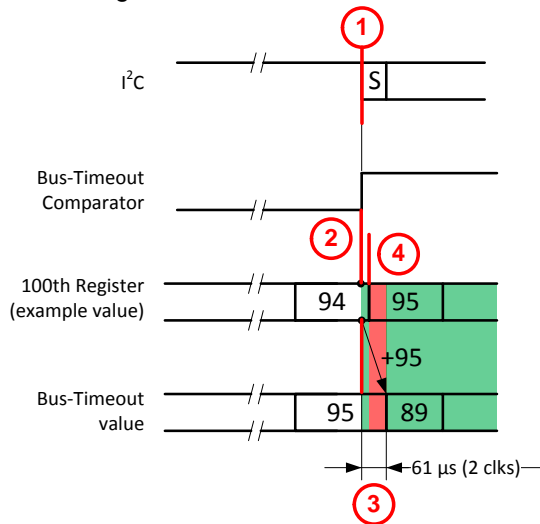
**Erroneous Bus-Timeout Reset Scenario 2: New START shortly before 950 ms after previous START**

- 1. At START condition, the comparator is enabled.
- 2. At the consecutive START the comparator is enabled with previous Bus-Timeout target value. As long as no match with the current 1/100th second is detected no RESET will be triggered.
- 3. It takes 2 clocks 32'768 Hz (61 μs) to update the new Bus-Timeout target value.
- 4. If during the 61 μs required for up-dating the Bus-Timeout value the 1/100th of Second is incremented and match the previous Bus-Timeout target value, the I<sup>2</sup>C Interface will be RESET.

Summarized: At START condition of the I<sup>2</sup>C Interface the Bus-Timeout comparator is enabled. The 1/100th Seconds register might have the value “previous Bus-Timeout value less one” and the RV-8803-C7 will replay with acknowledge. As soon as there is a match between the current value in the 1/100th Seconds register and the previous set Bus-Timeout value, the comparator triggers an I<sup>2</sup>C Bus-Timeout RESET and the RV-8803-C7 will reply with “no acknowledge”.
